BEAR SWAMP LAKE

DAM NO. 2

PHASE I INSPECTION REPORT

NATIONAL DAM SAFETY PROGRAM

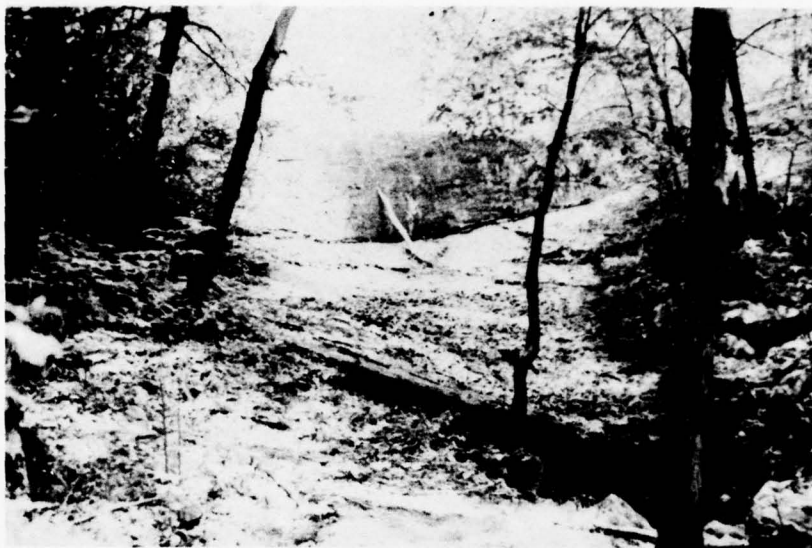
Photo 3 - View of dam and spillway from downstream showing concrete apron and plunge pool below spillway.

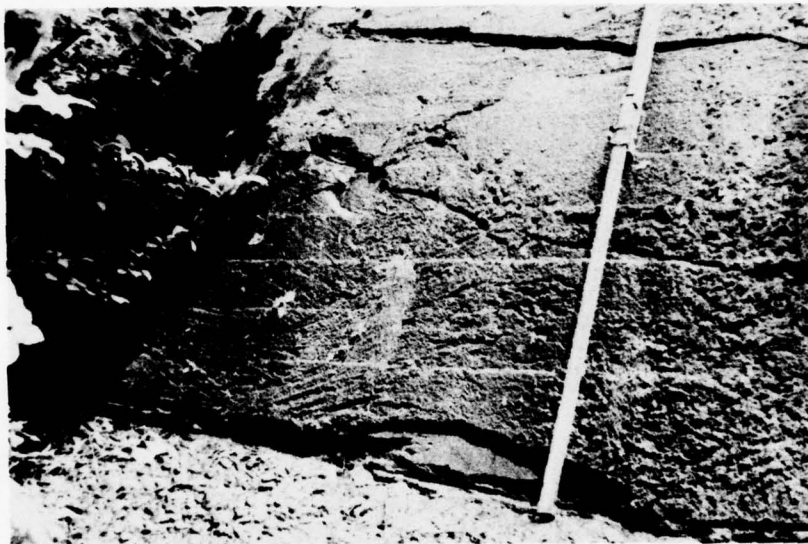
A structural crack has occurred through the spillway about 10 feet from the right side. Leakage in the order of 0.5 g.p.m. was observed in this area. Some minor leakage was also observed from two horizontal construction joints in the spillway. No serious cracking was observed in the spillway apron.

VISUAL EXAMINATION OF	OBSERVATIONS	REMARKS OR RECOMMENDATIONS
SEEPAGE OR LEAKAGE	Leakage through structural crack in spillway-trickle leak estimated to be about 1/2 gpm. Two small trickle leaks through horizontal construction joints (too small to estimate flow). No evidence of seepage can be seen downstream of the dam.	Repair reservoir face of dam by 6 inch slab method used in past or other suitable waterproofing method to minimize seepage through dam.
STRUCTURE TO ABUTMENT/EMBANKMENT JUNCTIONS	Both abutments are bedrock with no evidence of past erosion. Contact between concrete and rock foundation appears good.	
DRAINS	None - N.A.	
WATER PASSAGES	See Outlet Works.	
FOUNDATION	Leaves and rotted vegetation have piled up at the downstream toe apparently causing minor deterioration of concrete surface above contact between concrete and rock.	Rotting leaves and vegetation should be cleaned away from toe of dam annually. Surface spalls and deteriorated concrete should be removed and surfaces repaired.

Photo 5 - Leakage and spalled surface on spillway right side.

Areas of deteriorated, spalled or seriously cracked concrete should be cleaned and patched annually to prevent progressive damage.

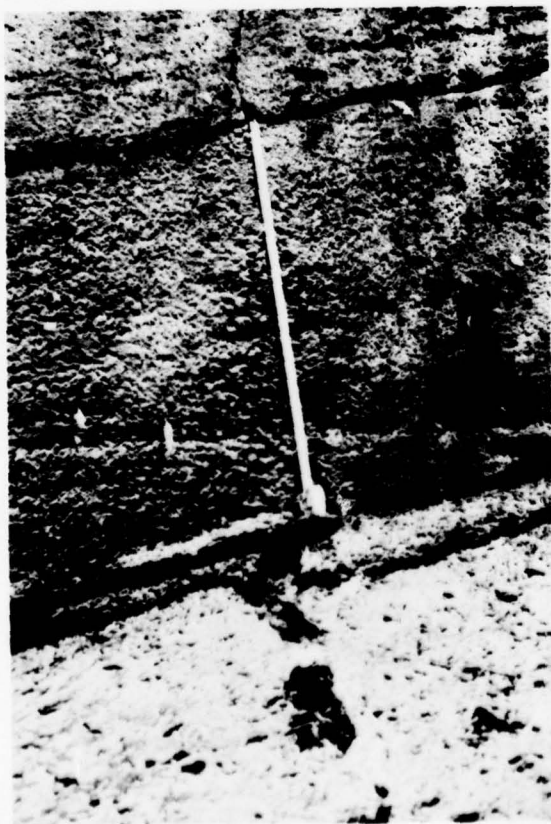
Photo 6 - Leakage through crack in spillway left side.

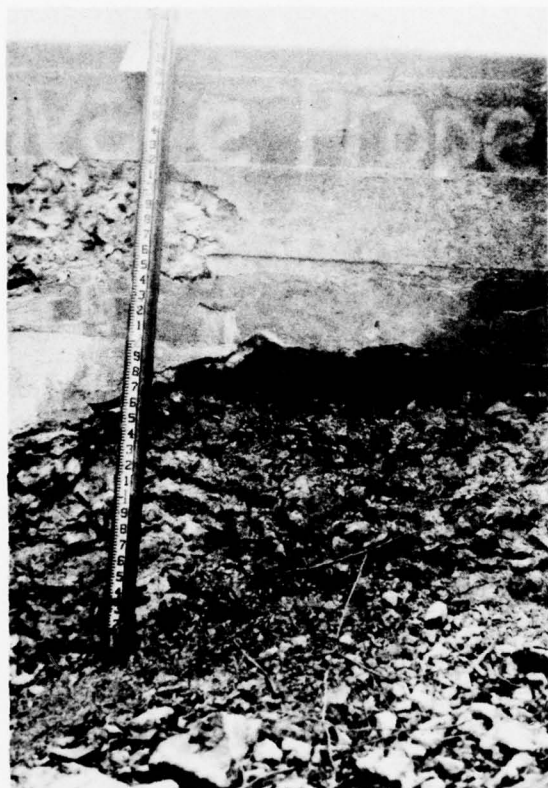
Some deep spalling has occurred at the toe of the section to the left of the spillway. Some leakage was visible in this area. A large horizontal crack has occurred in the section to the right of the spillway. No leakage was apparent in this location. Minor frost spalling has occurred on the upstream face. Construction joints appeared to be tight. There were no indications of either horizontal or vertical movement of the structure.

VISUAL EXAMINATION OF	OBSERVATIONS	REMARKS OR RECOMMENDATIONS
SURFACE CRACKS CONCRETE SURFACES	Moderately rough due to weathering. Some deep spalling at toe on left abutment. Hairline shrinkage cracks on top of crest parapet.	Inspect dam annually to detect new seepages and/or spalled areas. Apply face slabs or other waterproofing to upstream face whenever new seepages are found.
STRUCTURAL CRACKING	Through crack exists in overflow spillway section about 10 feet from right side of spillway. Trickle leak through crack. Too small to estimate flow.	Repair crack on upstream face to stop flow through crack. See above.
VERTICAL AND HORIZONTAL ALIGNMENT	No evidence of movement is apparent.	
MONOLITH JOINTS	No monolith joints can be identified.	
CONSTRUCTION JOINTS	All construction joints are tight.

Photo 7 - Spalling and leakage
near left abutment.

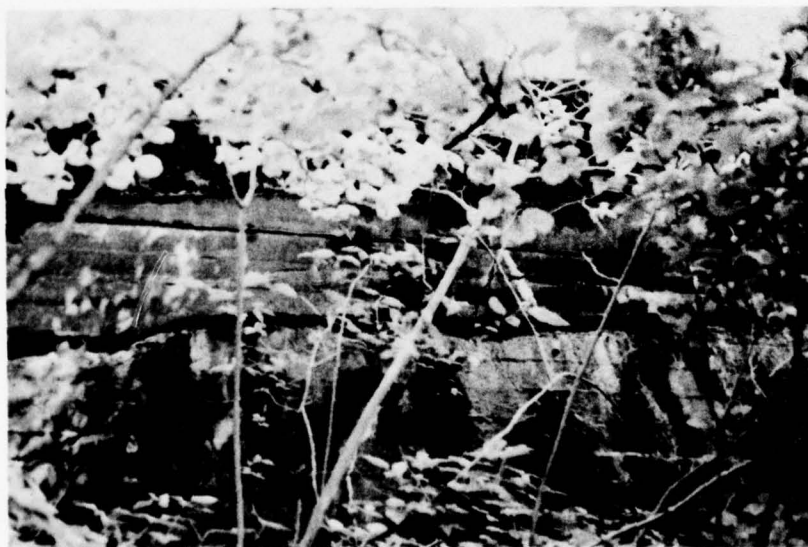
Photo 8 - Horizontal crack right side near abutment.
